Material Migration Patterns and Overview of First Surface Analysis of the JET ITER-like Wall

***14th International Conference on Plasma Facing Materials and Components
14-17 May 2013***

- First JET ITER-Like Wall Campaign 2011-2012
- Intervention
 - Remove and replace tiles from divertor and main chamber
 - Remove and replace erosion/deposition diagnostics
 - Detailed in-vessel photographic survey

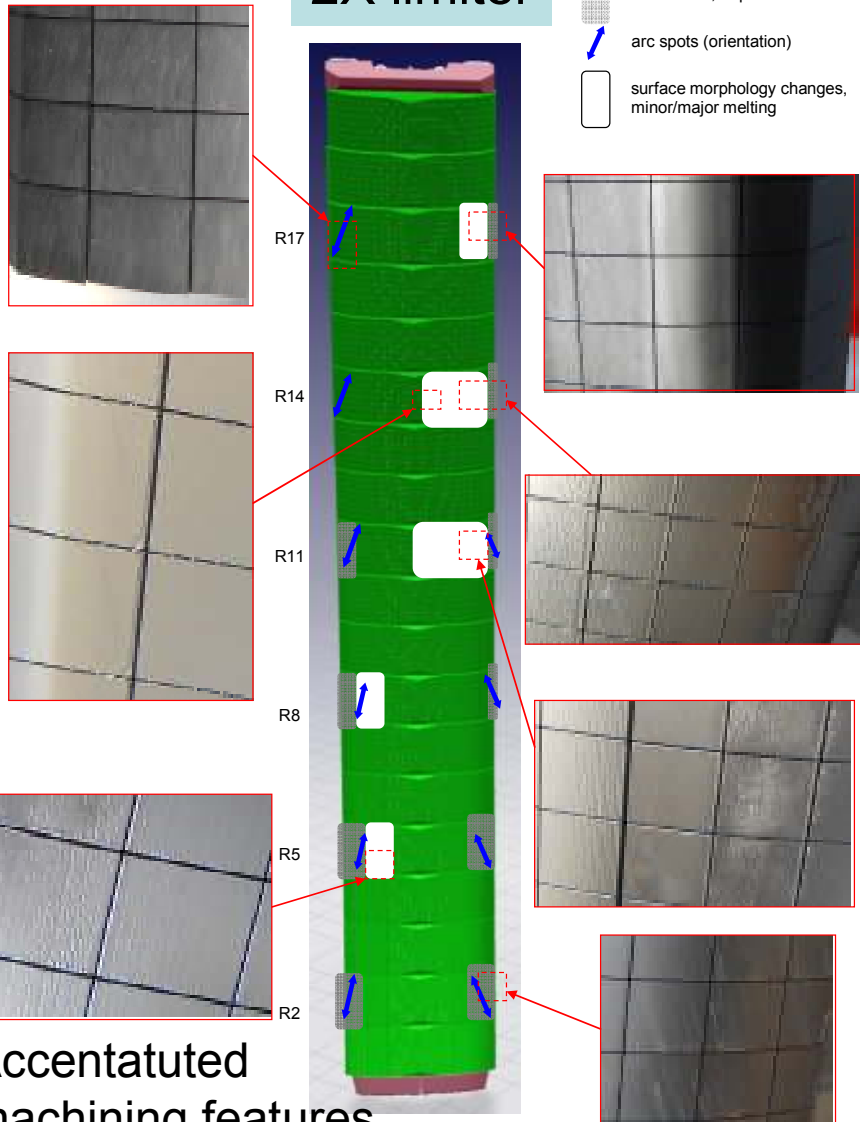
2X limiter

Arcing

dark areas, deposition
-

arc spots (orientation)
-

surface morphology changes, minor/major melting

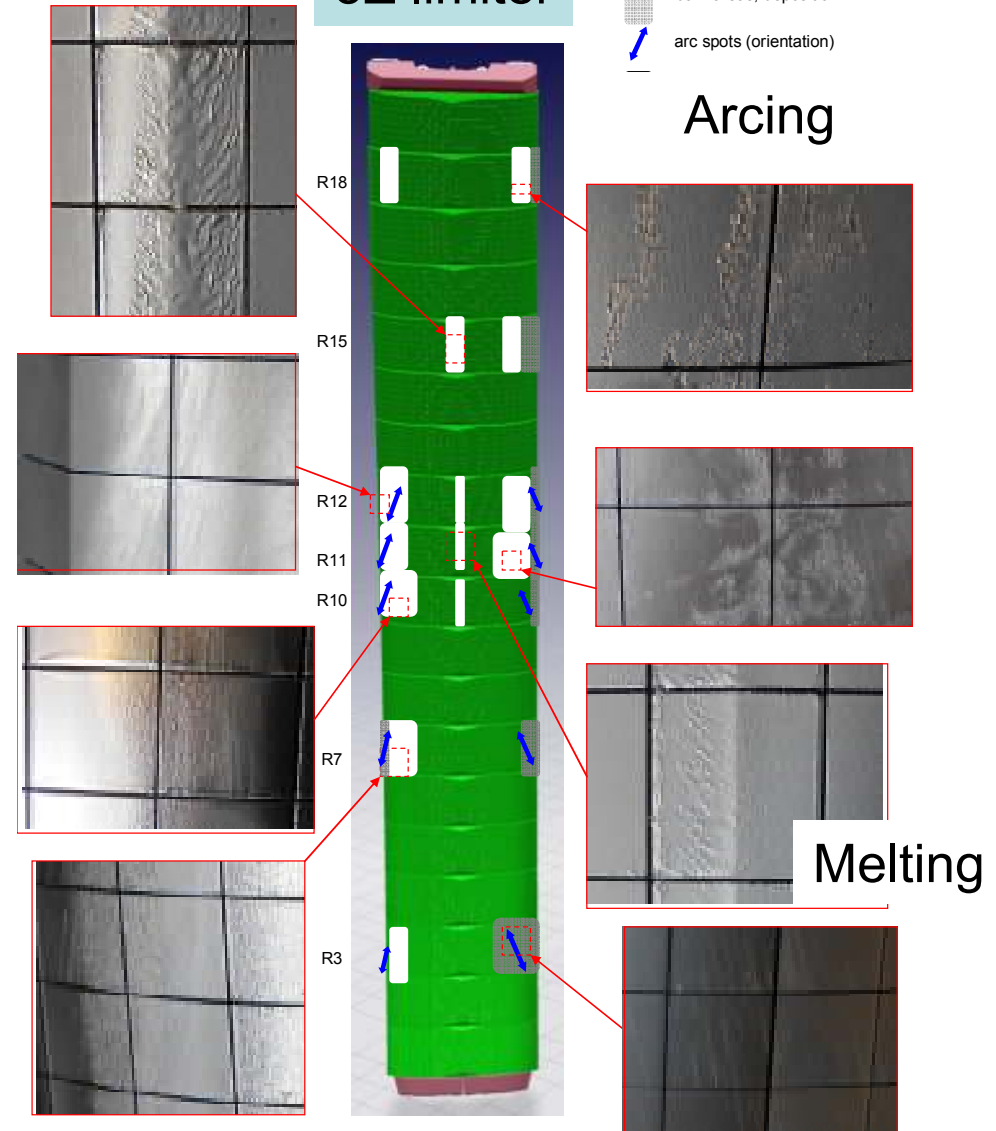
5Z limiter

Accentuated machining features

dark areas, deposition
-

arc spots (orientation)

Arcing

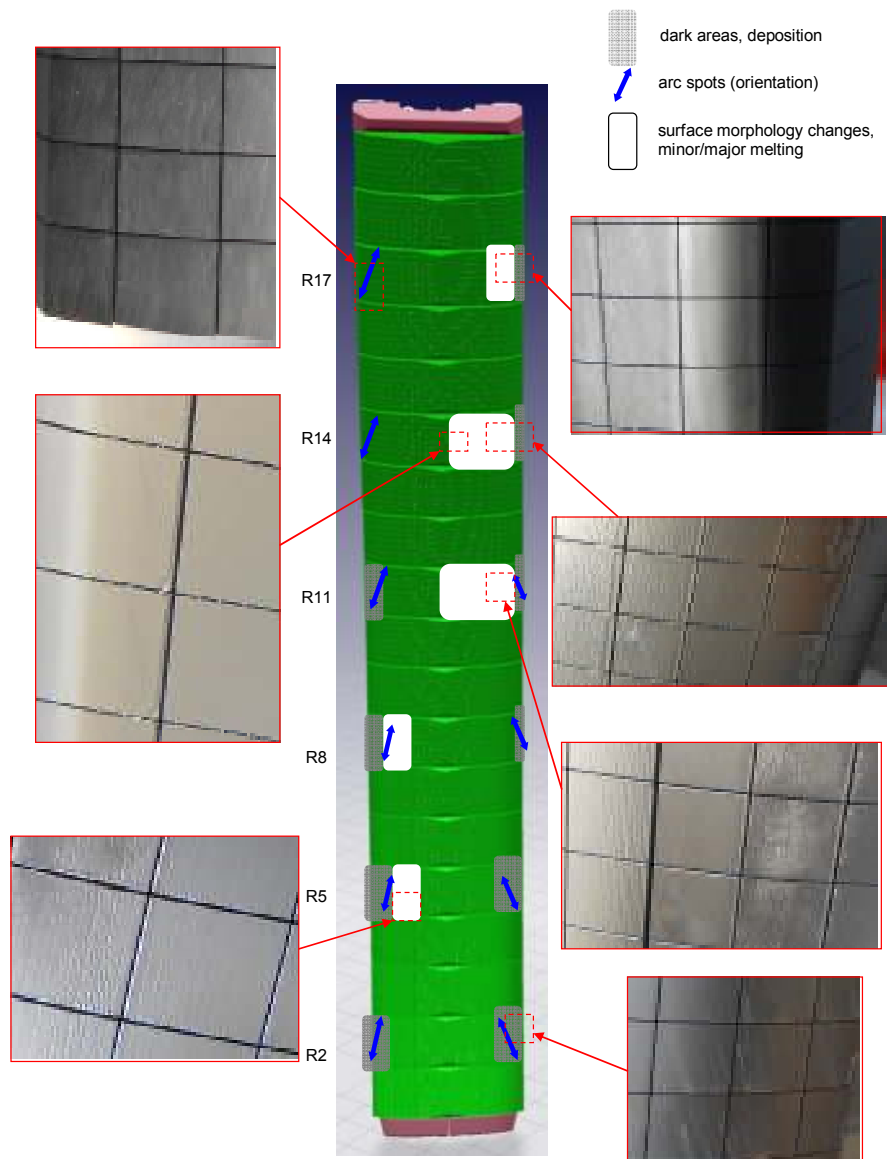
Melting

- Melting occurs during limiter phase
- More limiter only plasmas to test the wall

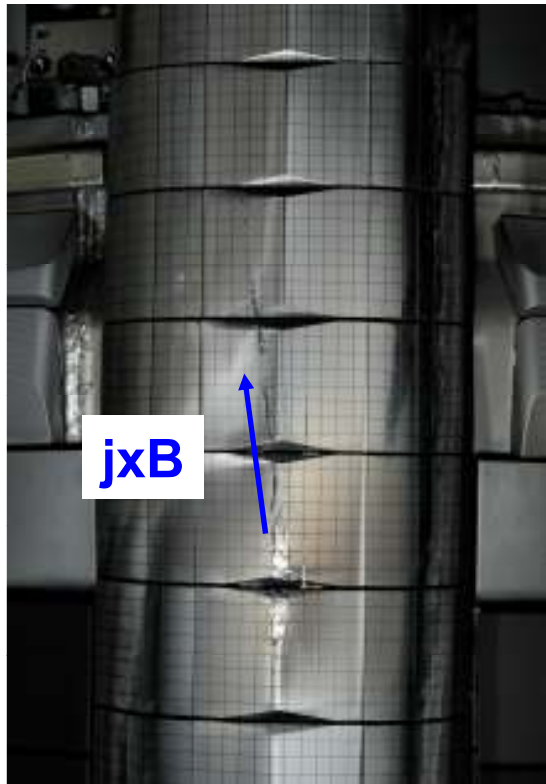
4X Limiter

- Strong melting on two limiters during one pulse to test Be wall
- The melt position is consistent with the contact point
- The melt material driven up by Lorentz $j \times B$ forces
- Melt flow can travel a considerable distance upwards even jumping across gaps
- Maximum temperature of 920°C was recorded at melting

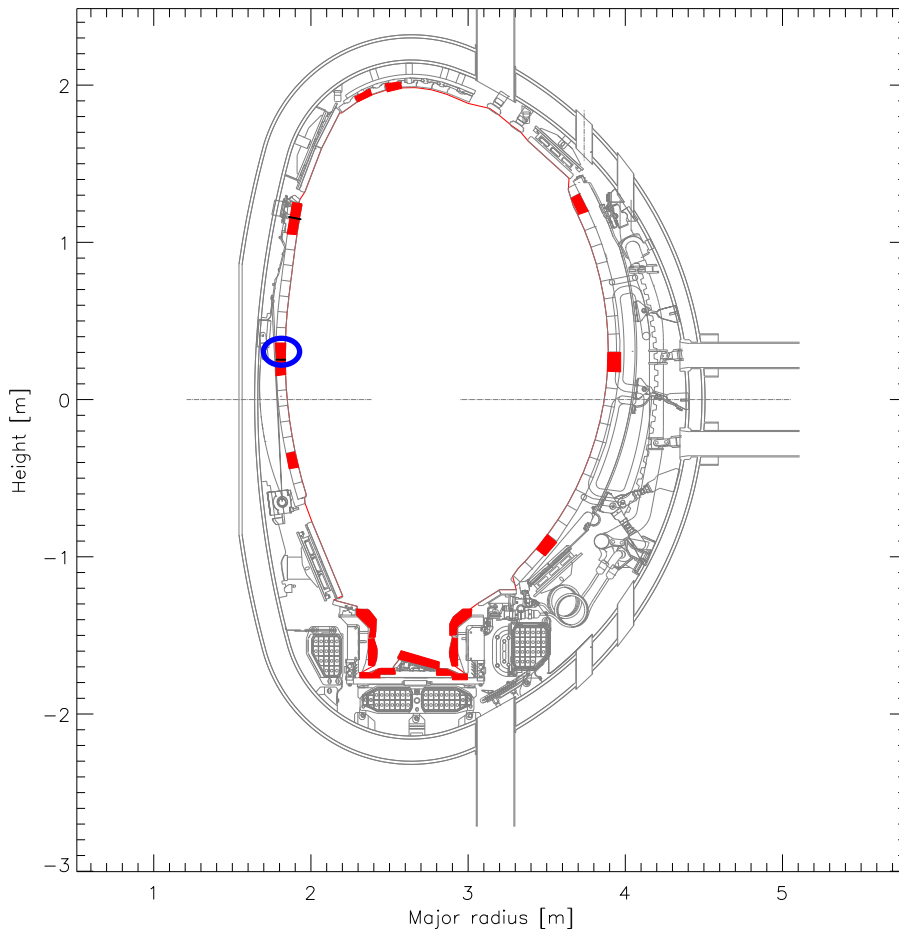
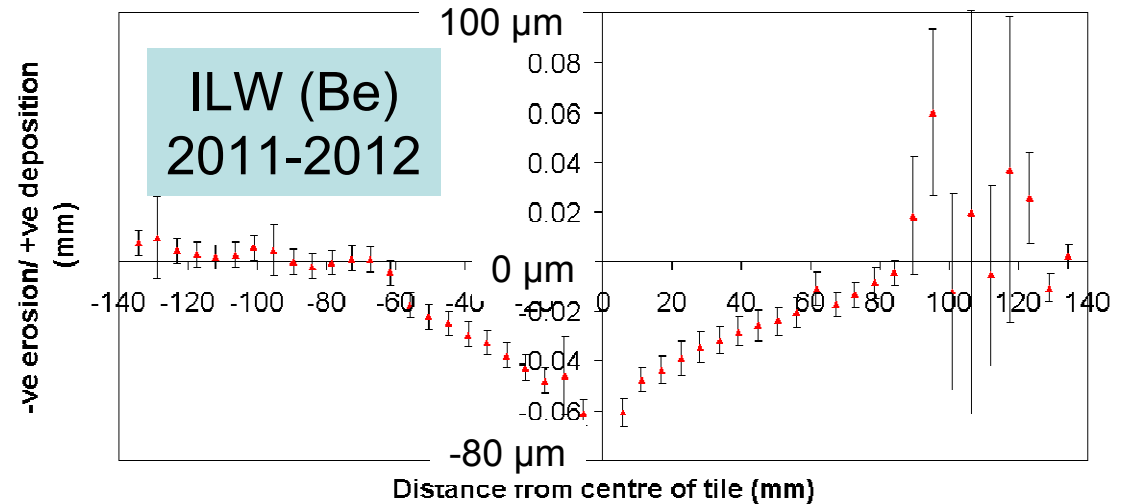
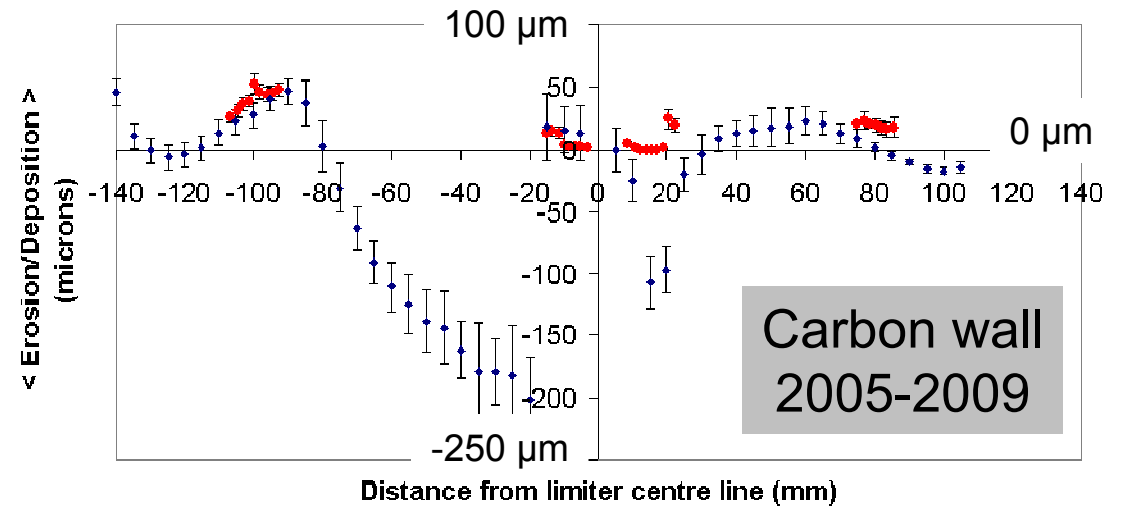
Comparison of erosion and deposition on mid-plane IWGL tile

Net erosion from mid-plane IWGL tile Beryllium vs Carbon

Net erosion rate (Atoms/s)
2005-2009 (C)	1.4e19
2011-2012 (Be)	2.3e19

Net erosion rate from one row of mid-plane IWGL tiles is higher for the beryllium wall than carbon wall

- 16 limiters for carbon wall
- 10 limiters for beryllium wall

Further analysis required to fully assess main chamber erosion and deposition

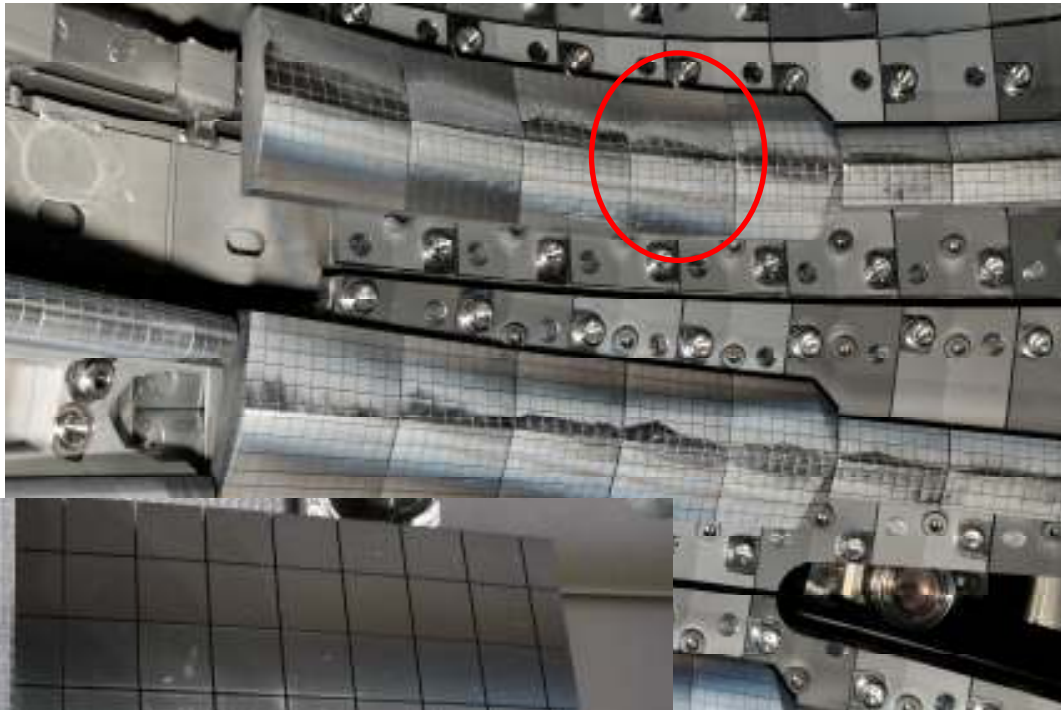
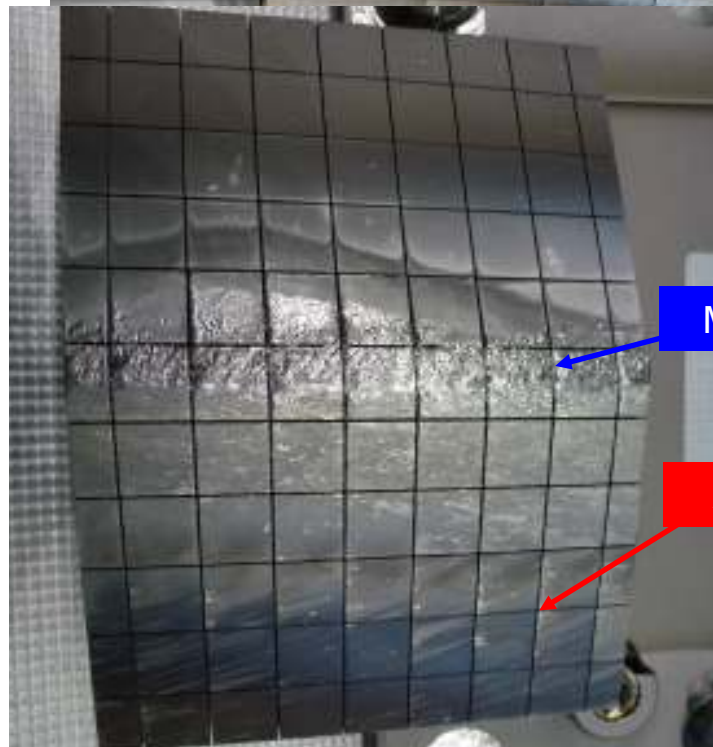
- Melt damage occurred prior to use of the disruption mitigation valve
- Toroidally uniform
- Additional source of beryllium erosion

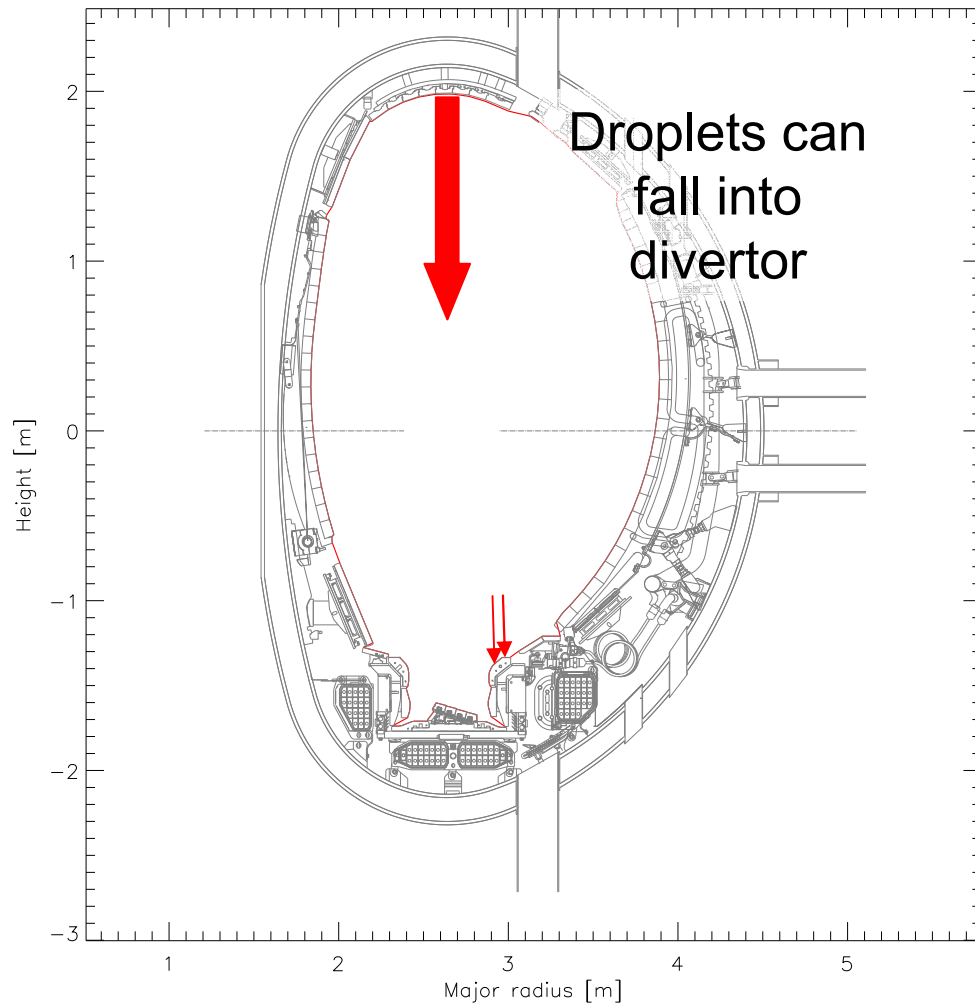
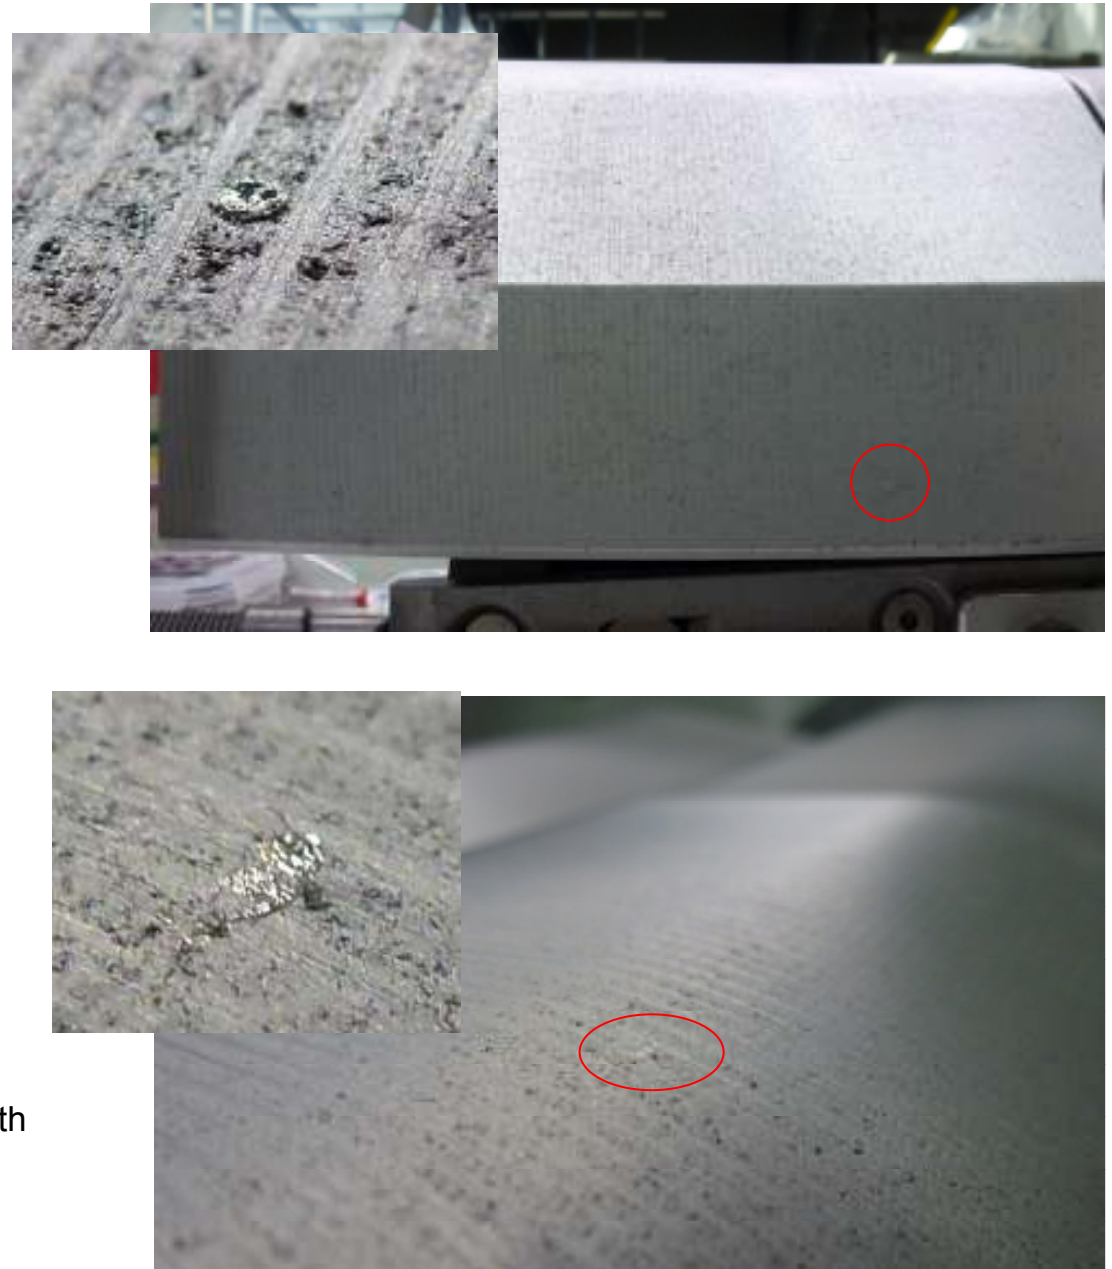
<10 beryllium droplets observed on 1/12th
divertor tiles closely examined

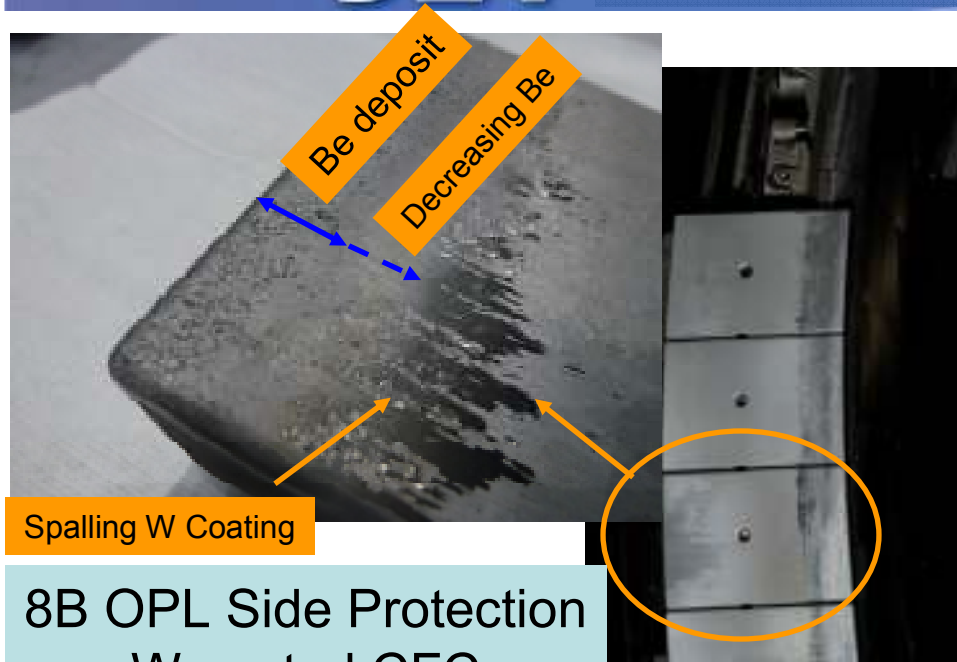
8B OPL Side Protection
W coated CFC

Example of Be deposition in the main chamber

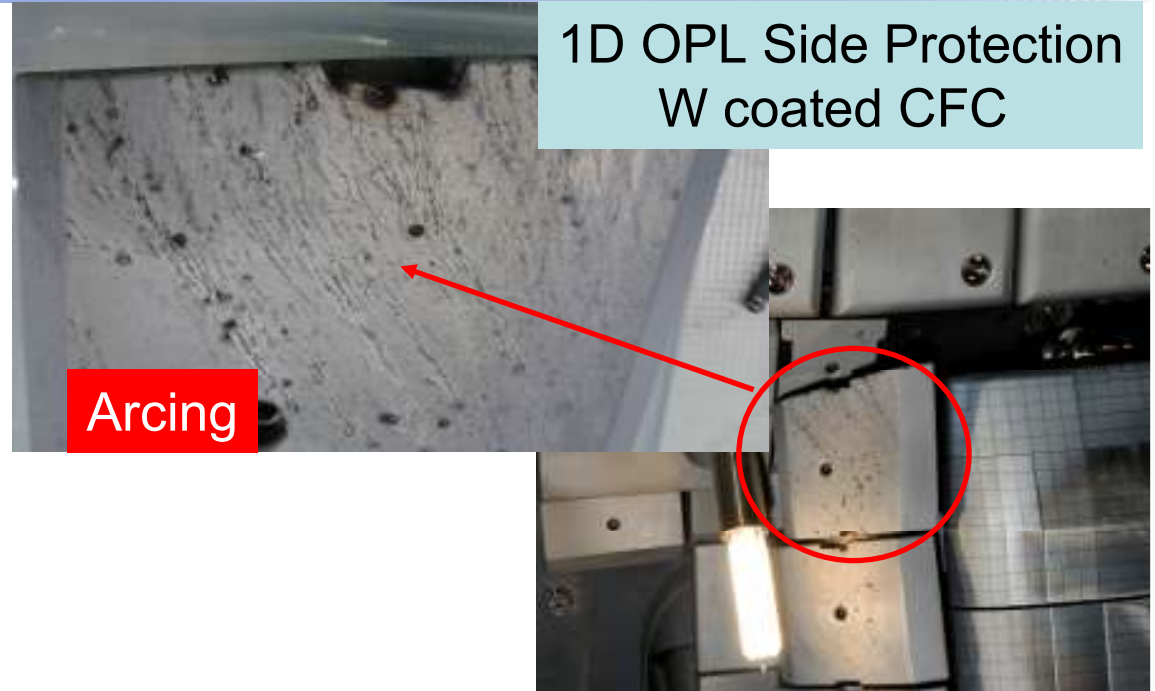
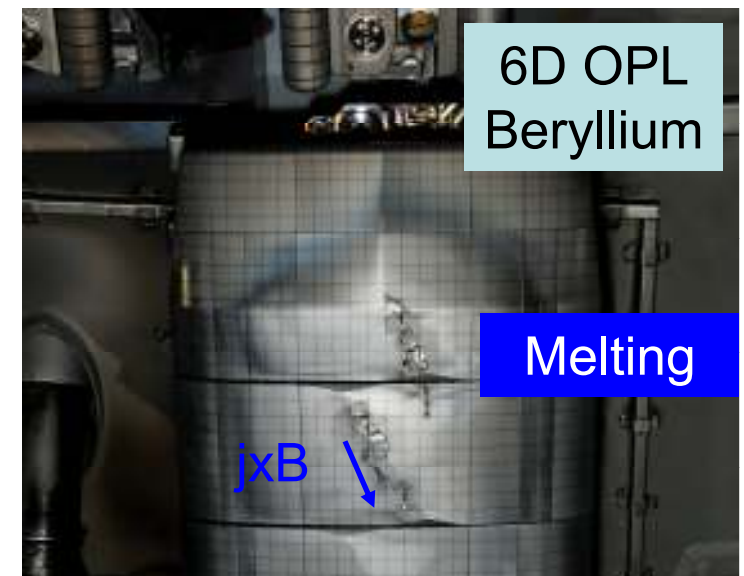
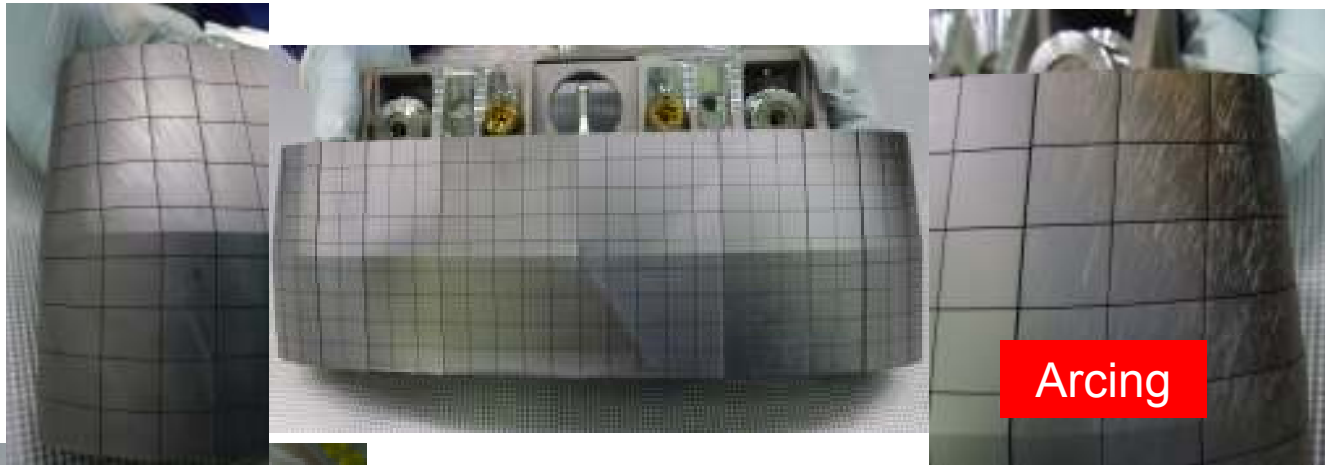
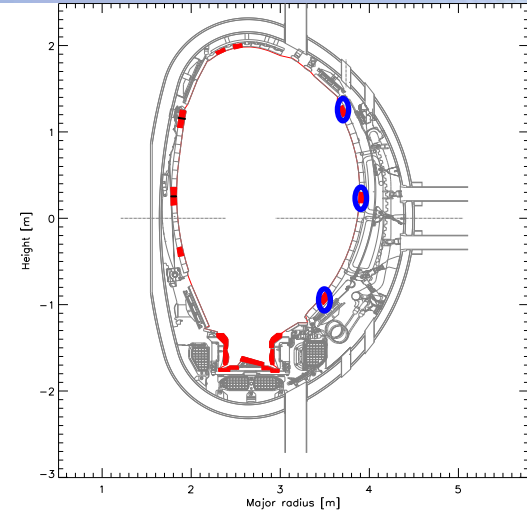
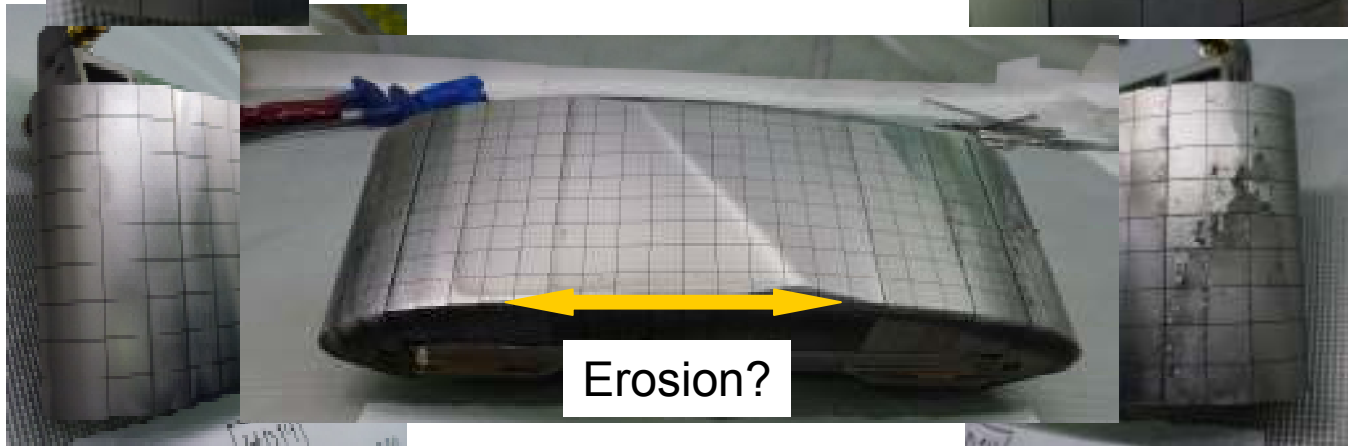
- 3 OPL tiles taken out for post mortem analysis
- Local deposition at outer ends of tile (also on side protection tiles)
- Possible erosion from centre of tile
- Spalling of marker coating at right hand end of tile
- Analysis of OPL tiles to be completed

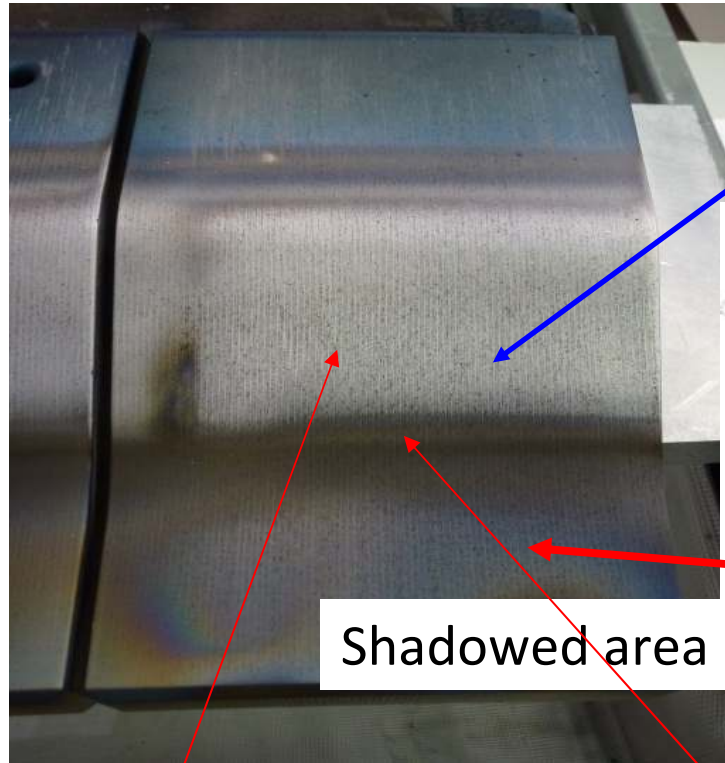
Inner divertor - Tile 4

Thin silvery deposit

Shadowed area

$\text{Be} \sim 3 \times 10^{18} \text{ atoms cm}^{-2}$
(~250nm)

$\text{Be} \sim 6 \times 10^{17} \text{ atoms cm}^{-2}$
(~50nm)

- Thin deposits have formed at the inner and outer divertor corner tiles
- No erosion/deposition observed from surface profile measurements

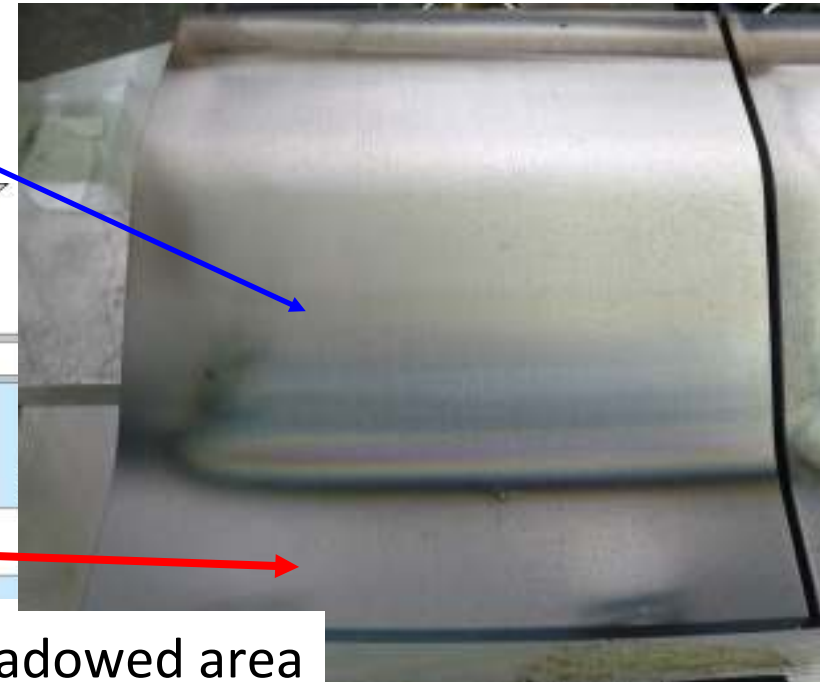
Outer divertor - Tile 6

Shadowed area

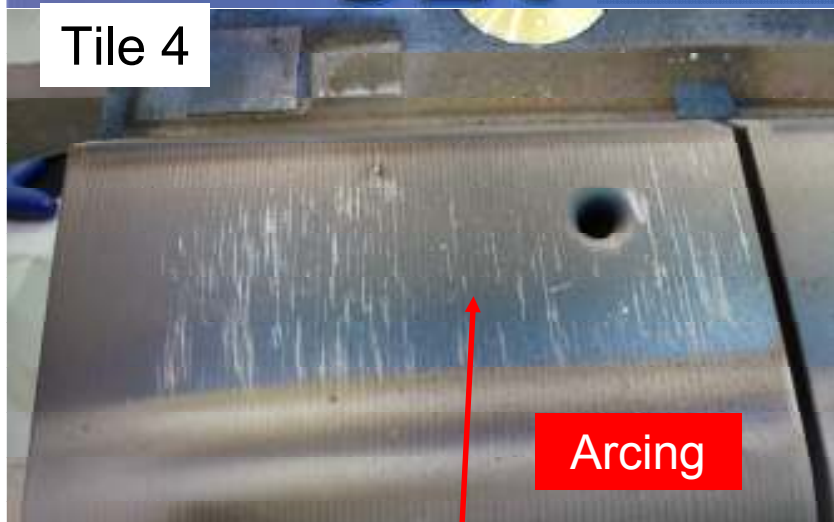
Tile 4

- Tungsten coatings are largely intact
- Arcing on tile 4 around whole vessel
- Delamination on tile 8 probably due to fibre orientation on top surface

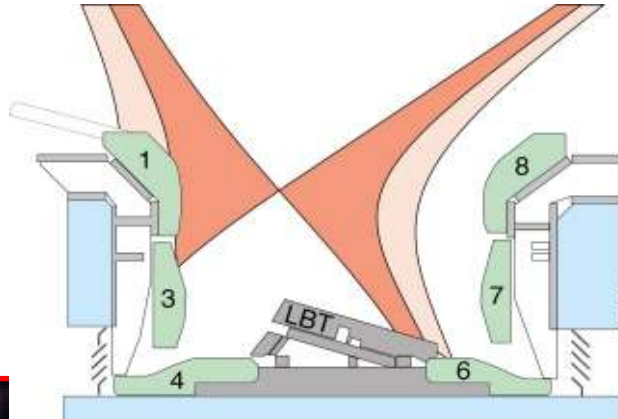
Inner Divertor

- Thin deposits – coloured fringes
- Deposits on mirror samples contain Be, W, D, Ni, C
- Be is dominant element

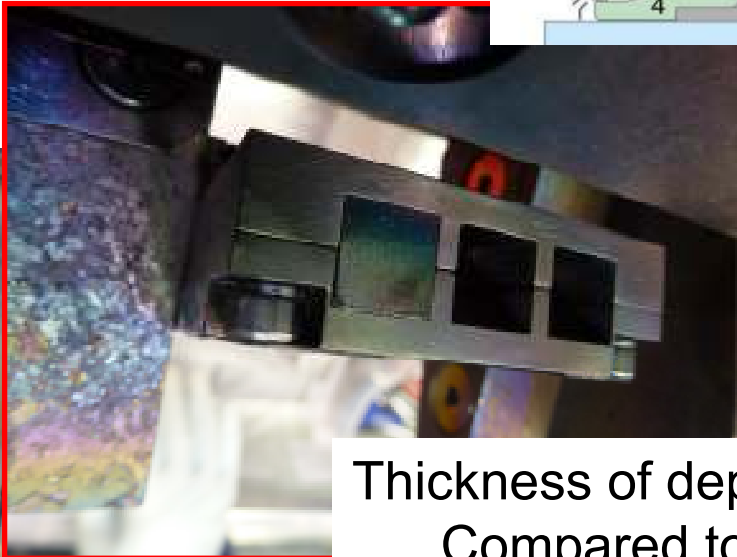
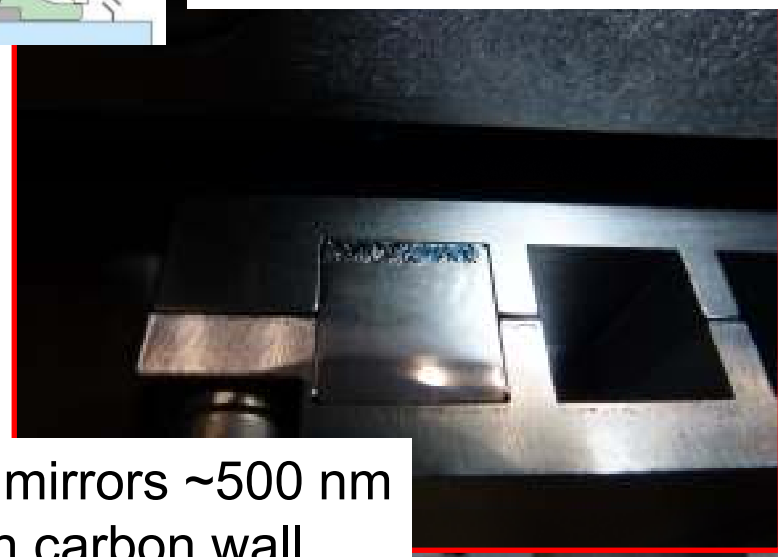
Outer Divertor

- Silvery deposits
- Deposits on mirror samples contain Be, W, D, Ni, C
- C from initial operations after intervention

Thickness of deposits on mirrors ~500 nm
Compared to 15 μm in carbon wall

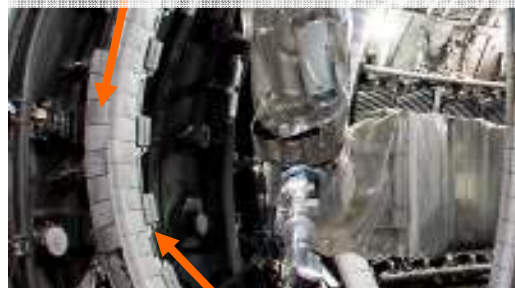
OPL side protection

- Be deposition on side protection tiles.
- Some delamination of W coating
